Progress Report for GSFC Four Stations 1 March to 31 March 1964

Prepared for Goddard Space Flight Center
Contract NAS 5-2462

SPACE SYSTEMS AND ANTENNA DIVISION

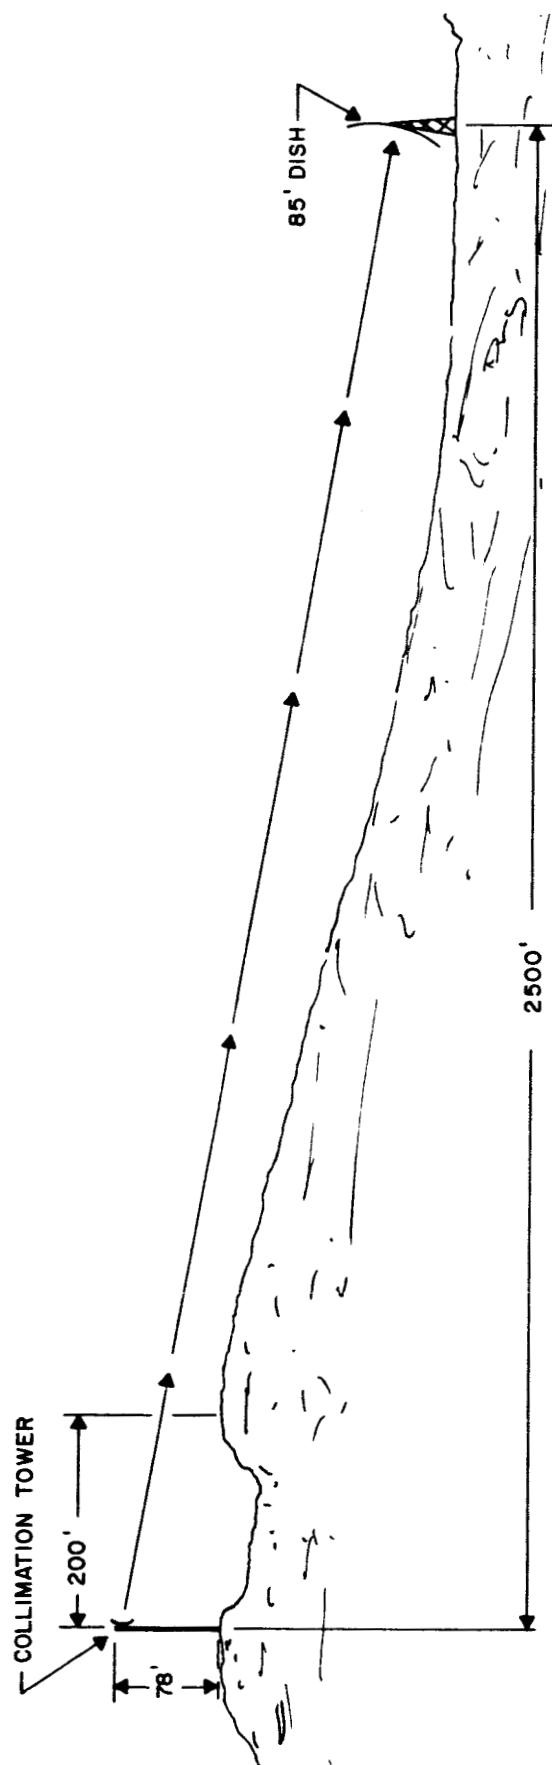
Figure 2-1. Terrain Cross Section for Near Collimation Range at Fairbanks II

Figure 2-1 shows an approximation to the terrain cross section for the range, using the near collimation tower. From this figure it can be seen that a low grazing angle is present, due to the shortness of the tower. In addition, there is a small hill approximately 200 feet from the tower which causes a knife edge diffraction effect. Both of these conditions can cause variations in field strength across the face of the dish. The variations due to knife edge diffraction were determined to be only 0.6 db using the Cornu Spiral technique. Thus, diffraction effects are negligible. The ground reflections are quite severe, however, and their effects can be approximated as follows:

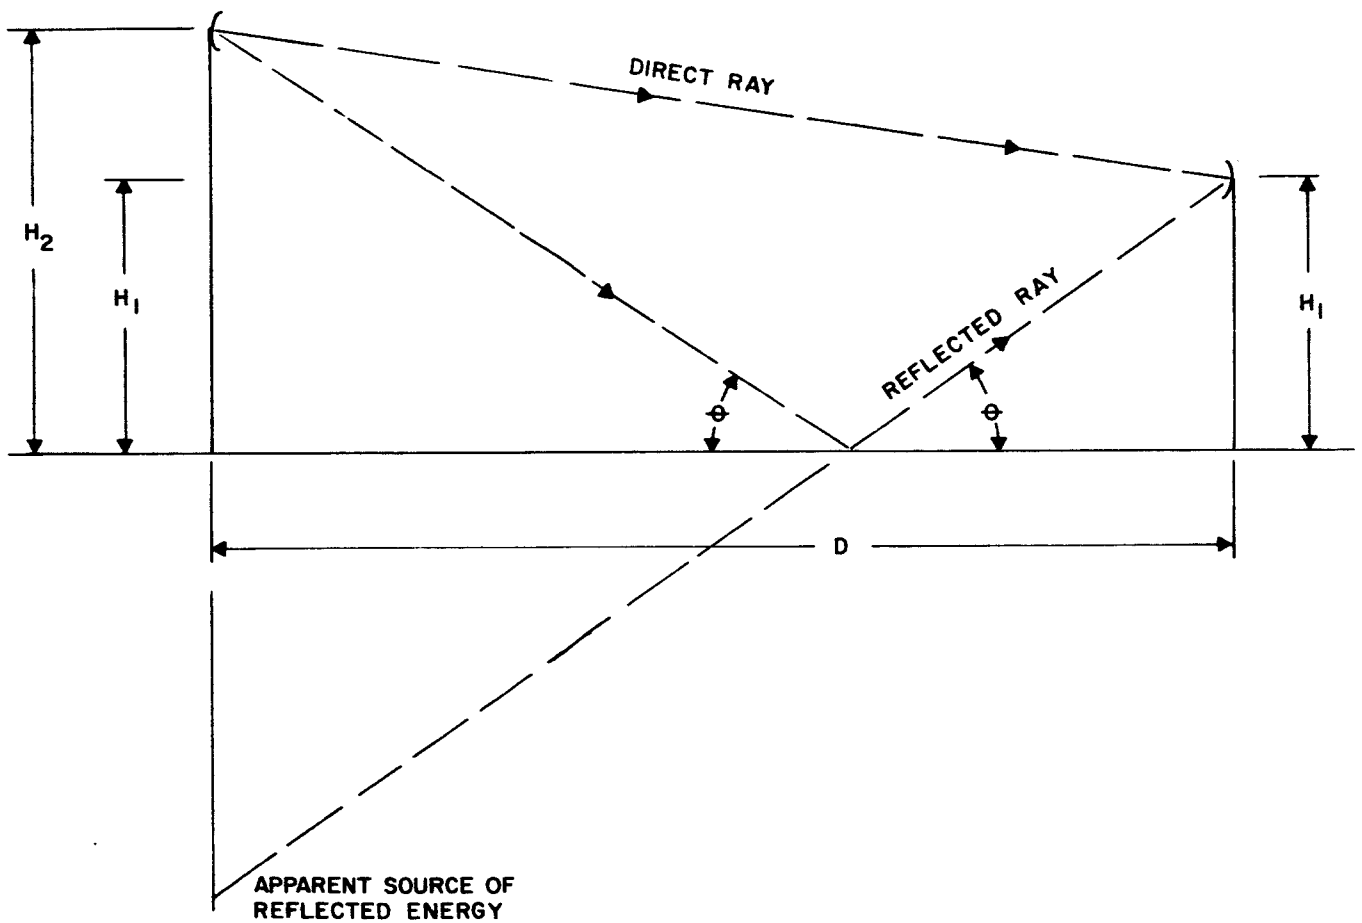
Figure 2-2. Simplified Range Geometry

From the simplified geometry shown in figure 2-2, it is apparent that the grazing angle of the reflected energy is given by

$$\theta = 2.3^\circ$$

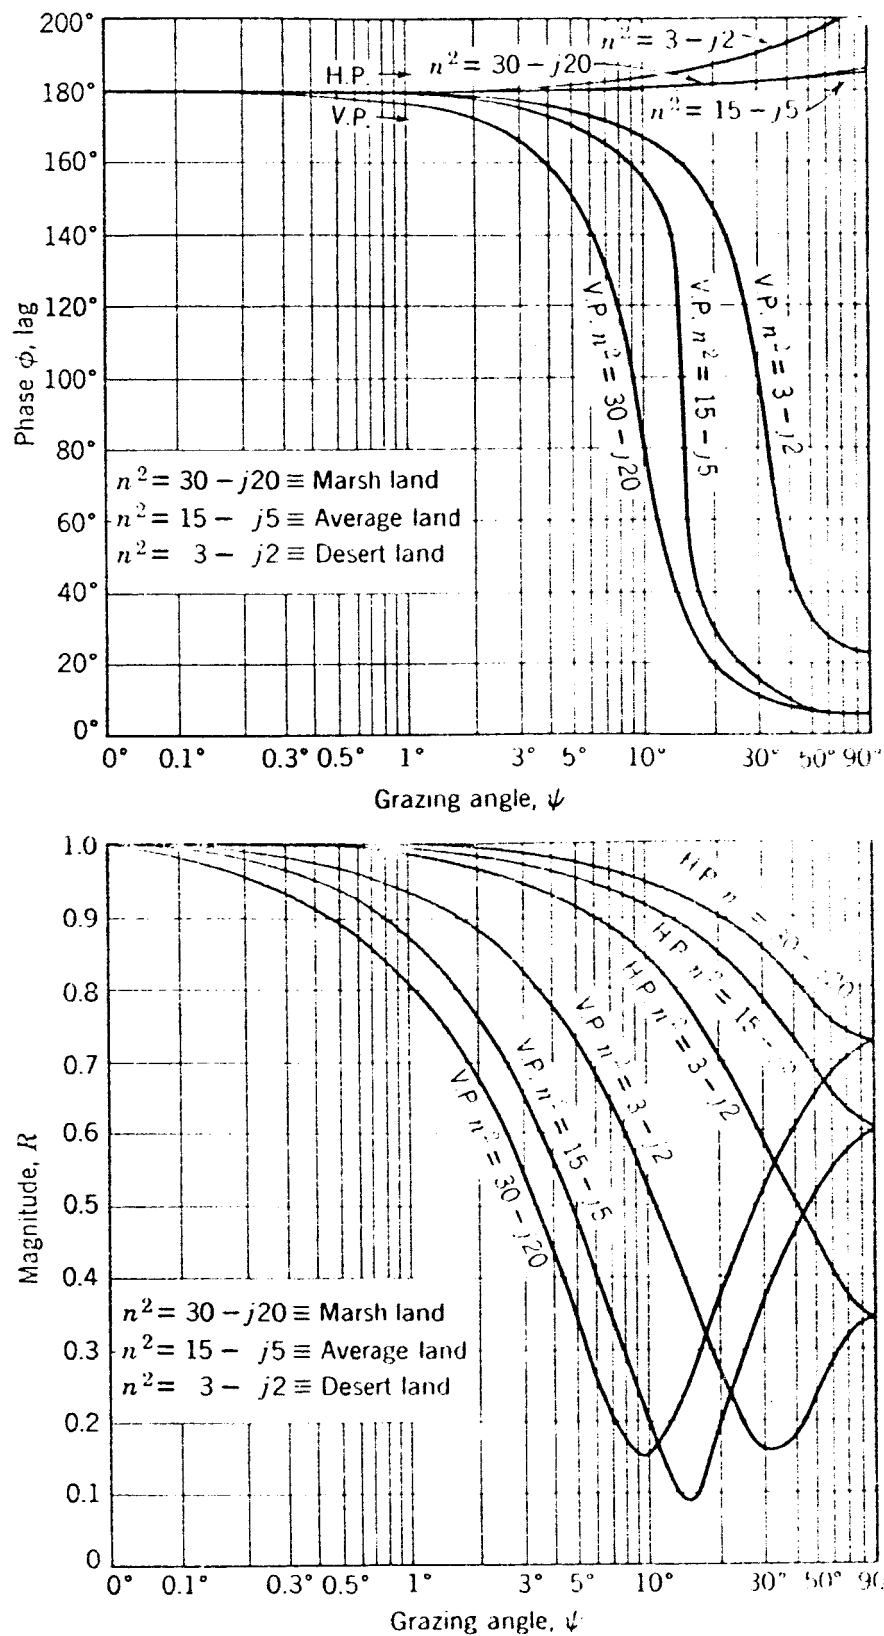
Figure 2-3. Magnitude R and Phase ϕ of Reflection Coefficient vs. Grazing Angle ψ for Smooth Land (Frequency: 100 mc)

The reflection coefficient, R , may be determined from the curves in figure 2-3.* Although these curves are for 100 mc, they may be used with little error at 136 mc, since the ground reflection characteristics change quite slowly with frequency. Using average land, the reflection coefficient for vertical polarizations is 0.7 while that for horizontal polarization is 0.975. The maximum and minimum field strengths at the 85-foot antenna are

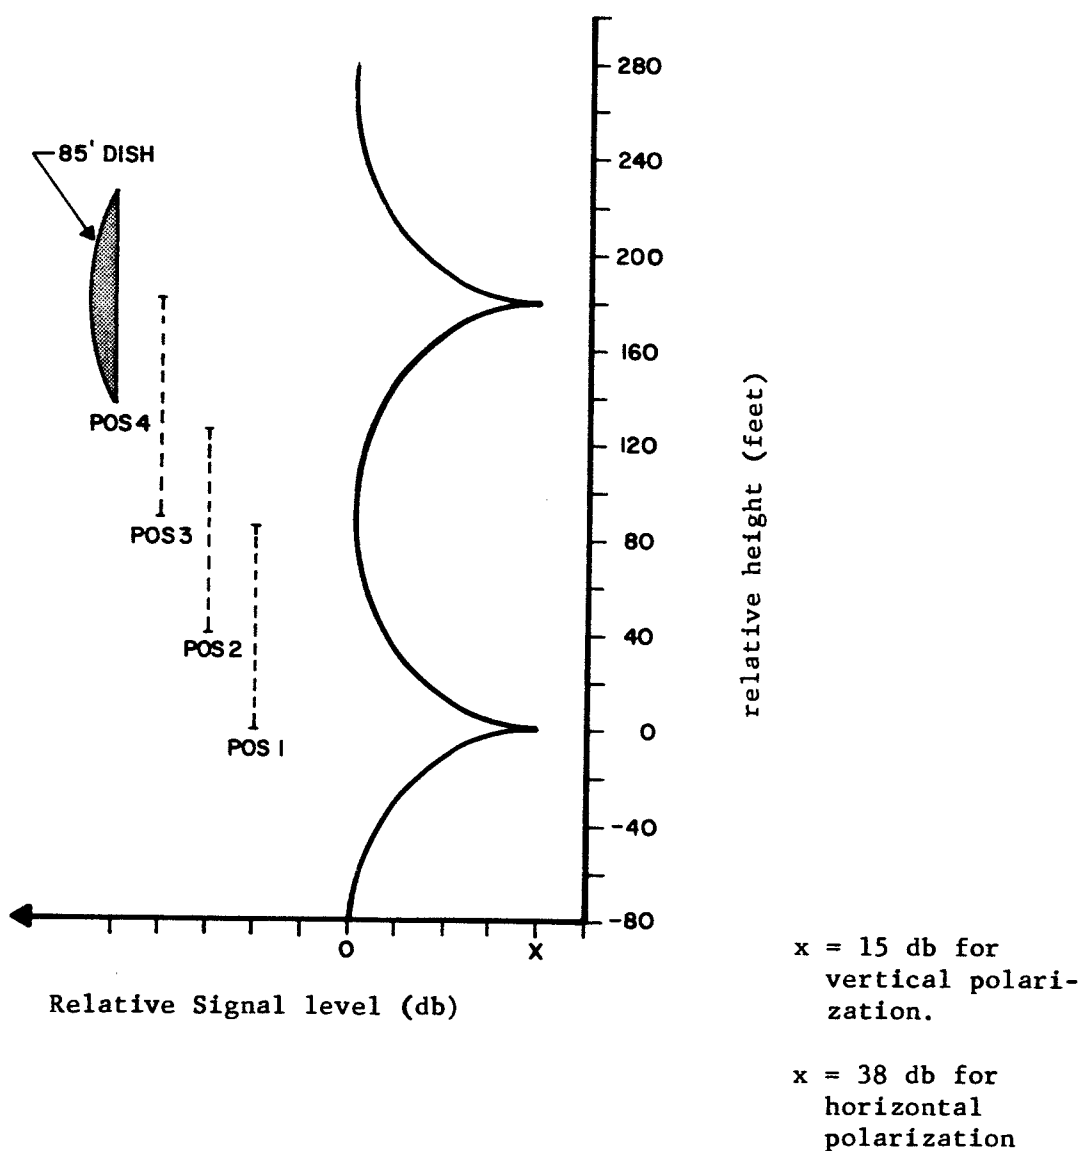
Figure 2-4. Possible Relationships Between the 85' Dish and the Interference Pattern

By chance, the null pattern can be located almost anywhere with respect to the 85-foot dish, as illustrated in figure 2-4. It is seen from this figure that variations of field strength across the surface of the dish can be as great as 15 db for vertical polarization or 38 db for horizontal polarization. This would occur in position 1 or position 3. For position 4, a null is present at the center of the dish and a phase change of 180° occurs across this null. For the actual case in the field, these amplitude variations may not be nearly so severe, since the assumption of specular reflection only approximates actual site conditions. However, their effects cannot be neglected. The effect of these reflections on system performance will now be considered. For simplicity,

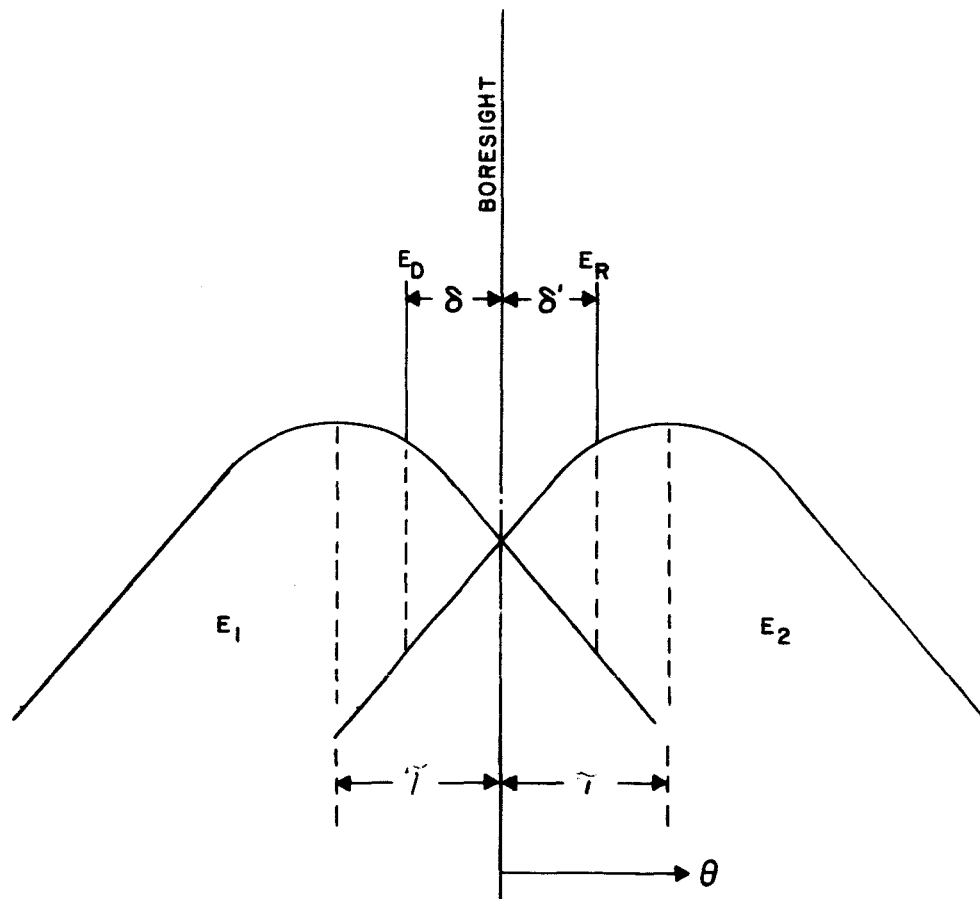
Figure 2-5. Squinted Beams of an Amplitude Monopulse Antenna

assume antenna patterns of the form $\cos K\theta$. If the value of K is properly chosen, this assumption provides a fairly good approximation to the area between the first nulls of the pseudo-Bessel function produced from this type aperture. For the purposes of this analysis, assume direct energy E_d and reflected energy E_r , arriving at an angle δ and δ' respectively in relation to boresight. See figure 2-5.

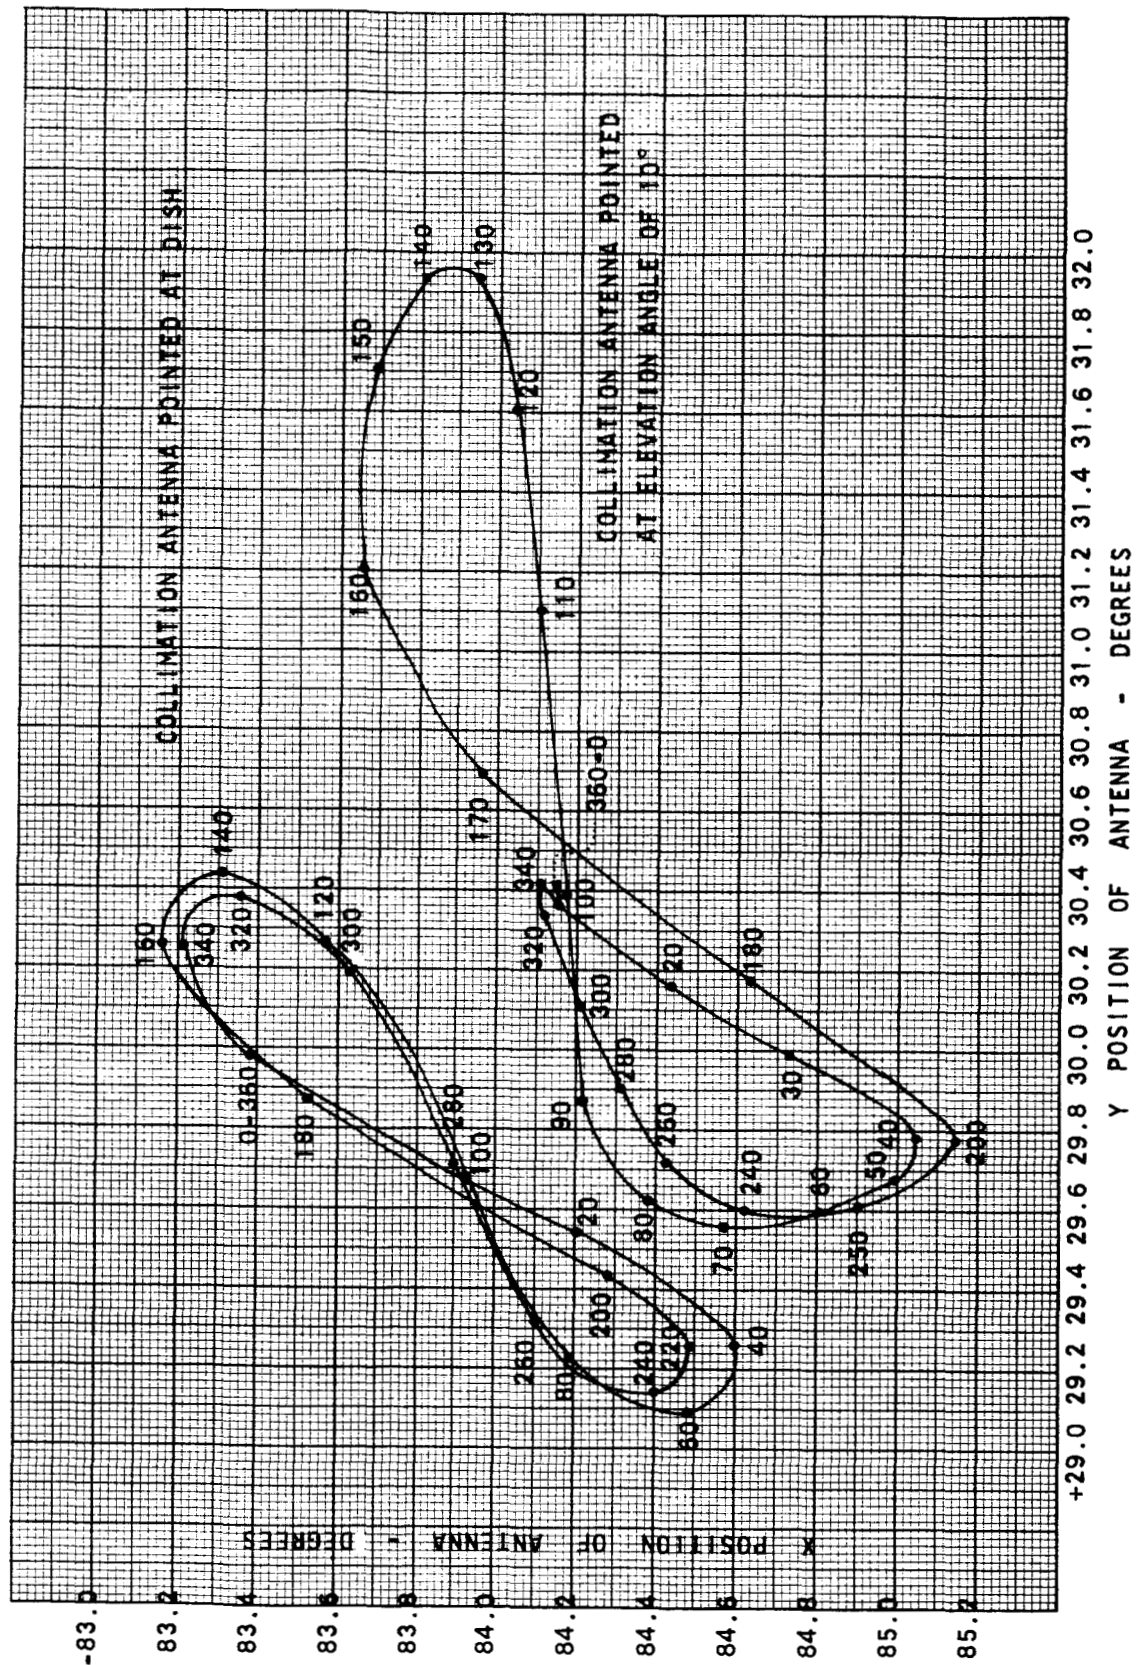
Figure 2-6. 136-Mc Boresight Shift with Polarization of Collimation Antenna

In conclusion, ground reflections can constitute a serious problem in predicting operational system performance on the basis of operation with a collimation tower. The above analysis has shown that at Fairbanks II the field variations across the aperture of the 85-foot dish could be as great as 15 db for vertical polarization and 38 db for horizontal polarization. In addition, it was shown that null filling of the difference pattern can occur due to ground reflections.

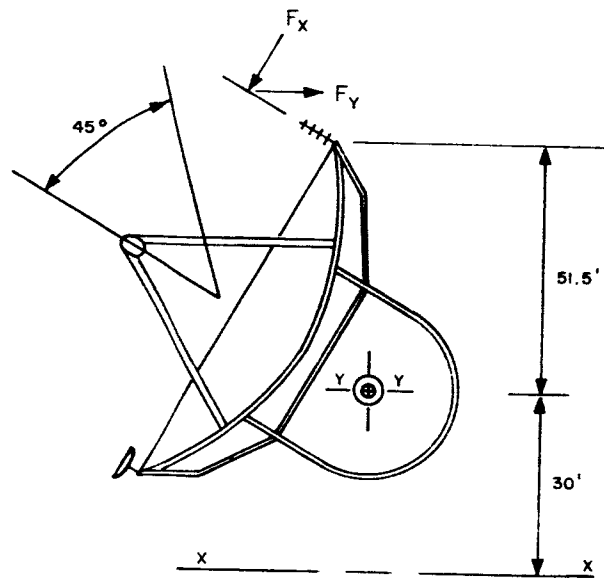
Figure 5-2. Command Antenna X-Y Orientation

The resultant force (F_R), at section A-A, on the command antenna as a result of a $12^\circ/\text{sec}^2$ constant acceleration, is found by determining the acceleration force about each axis independently and the following relationship:

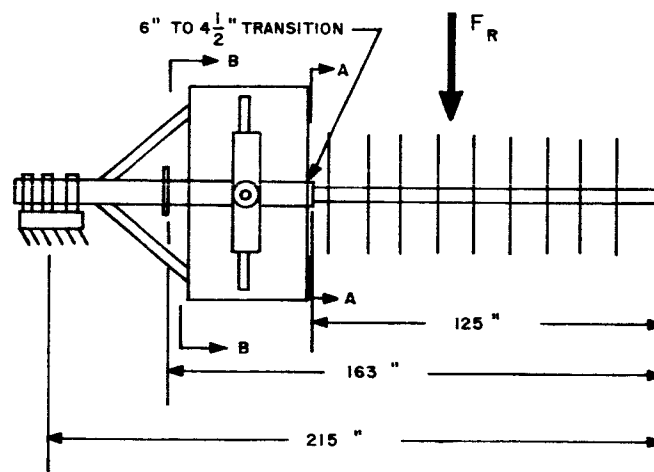
Figure 5-3. Command Antenna, Outline Drawing

The command antenna at the Rosman I tracking station has experienced three mechanical failures since the initial installation. Each failure has occurred in or very near a welded section.

The first two failures occurred in the weld of the transition between the 4-1/2-inch and the 6-inch mast sections. The welded joint was not sufficient to carry the bending moment imposed on that section. Gusset plates were added in order to carry the bending moments across the weld area.

The third failure occurred in the heat affected weld zone of the mounting tube. The original mounting tube (6061-T-6 aluminum, 3/16-inch wall) was changed to a carbon steel tube with a 0.237-inch wall thickness. This material change increases the allowable bending moment by 4.56. The factor of safety for the mounting tube section is now 3.9 * for an inertial load of $12^\circ/\text{sec}^2$.
